## Document showing phases in repairing rudder

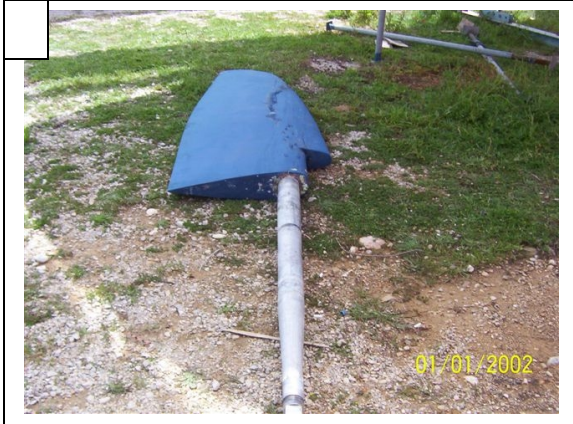
Dismantled right after haul out – date  
April 18 08

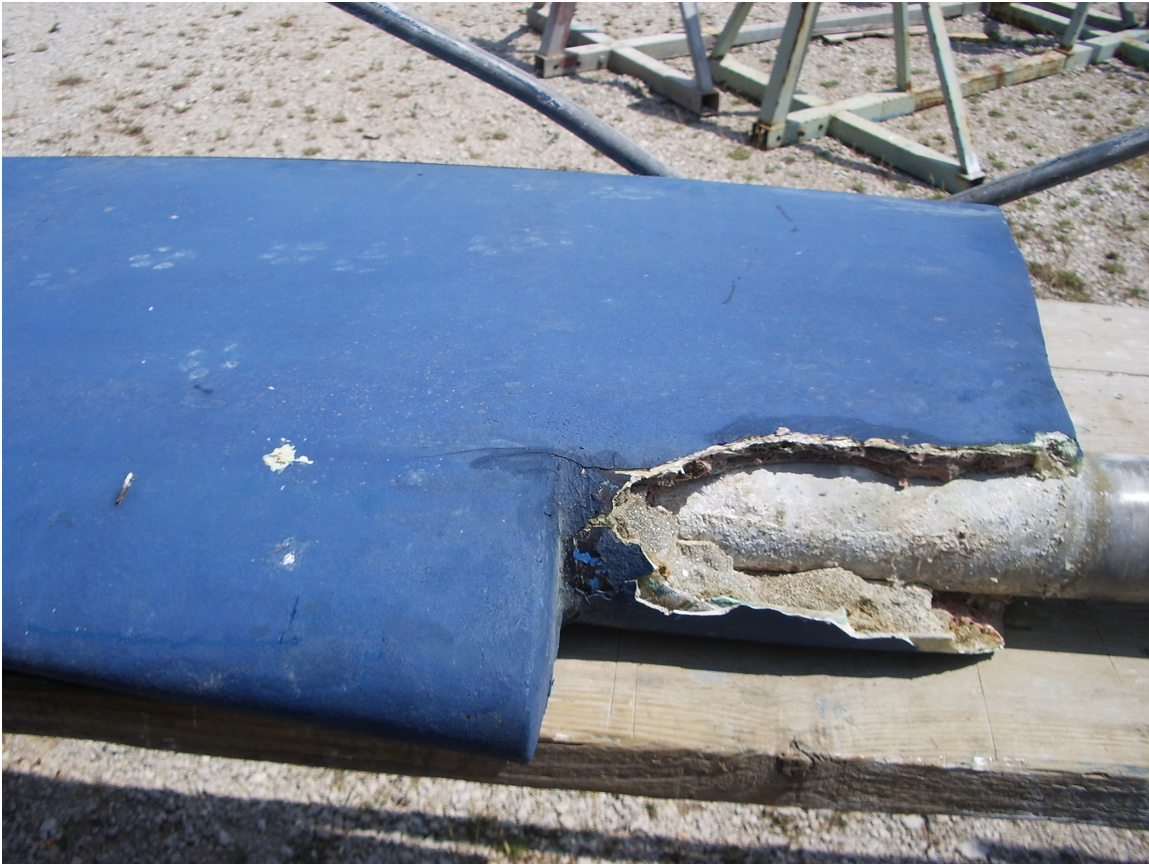
Rudder – now showing the main damage. – June 08

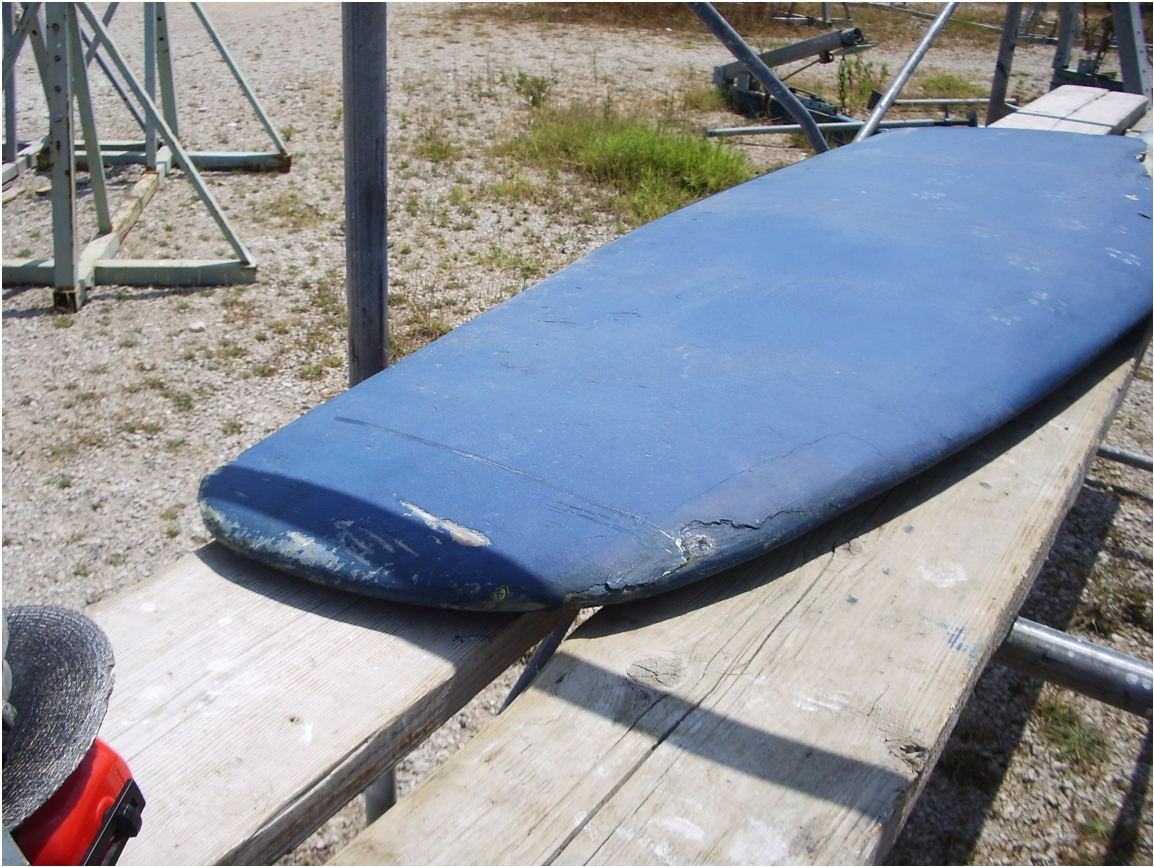
Rudder – now showing the hit spot in the front bottom– June 08
